Reconstructions of the Gothic past: the lost cathedral of Waterford

ROGER STALLEY

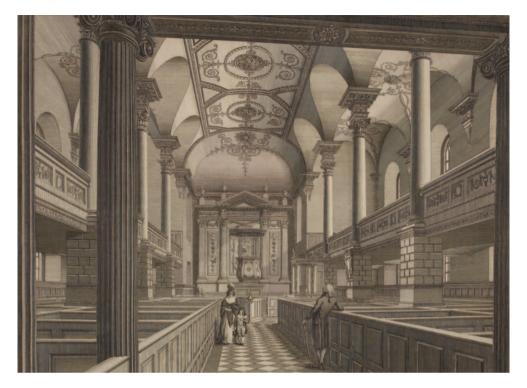
2 – Thomas Malton, Christ Church Cathedral, Waterford, c.1785 (courtesy National Library of Ireland)

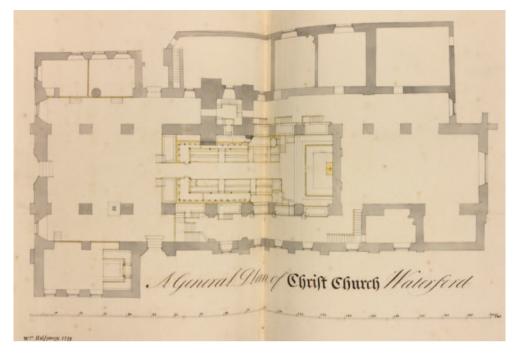
3 – William Halfpenny, plan of Waterford Cathedral, 1739 (courtesy British Architectural Library, RIBA, London)

It is unfortunate that we do not know why the cathedral authorities in 1739 commissioned Halfpenny to prepare a plan of the medieval cathedral, along with three drawings of the exterior (Plates 7-9). If internal renovations were being contemplated, one might have expected interior views as well, but there is no evidence of such drawings (unless they have been lost). Even more curious is the fact that in the very same year, Jonas Blaymires arrived in Waterford to prepare a similar set of views or 'prospects' of the cathedral, as well as a plan. Blaymires was there in April, whether before or after Halfpenny we do not know. Commissioned by Walter Harris, the drawings of Blaymires are the source of the three well-known engravings published in *The Whole Works of Sir James Ware* (Plates 4-6). On his visit to Waterford, Blaymires received a less than forthright welcome. In a letter to Harris, he explained that he had done a plan, along with two prospects 'which are greatly approved of', but added that the bishop and dean were reluctant to contribute towards the cost of the work and would not pay for the plan. He waited around for ten or eleven days in the hope of receiving some cash. 'The Bishop at parting told me he would pay for the Northwest side provided that the rest was to be

around the cathedral had risen quite considerably, a point evident from the Blaymires and Halfpenny plans on which steps are shown leading down into the church (Plates 3, 4). The eighteenth-century cathedral was thus built at a higher level than the medieval building, the outer walls of which provided a foundation for the new.

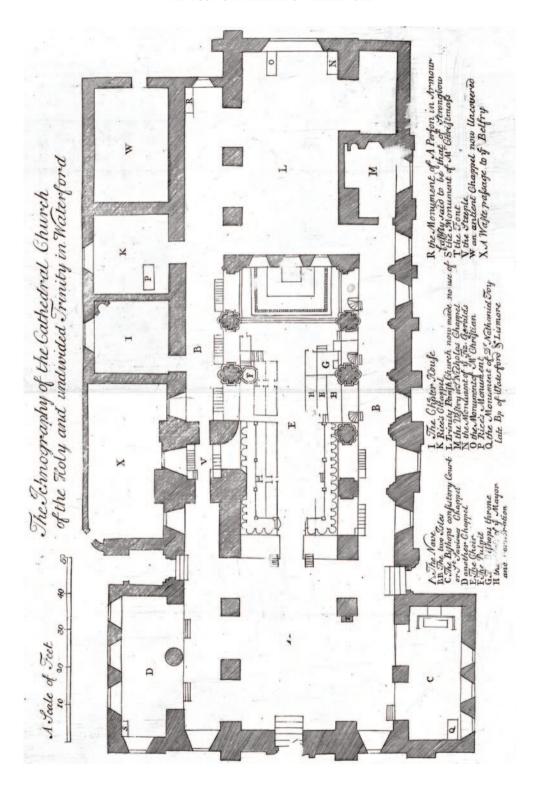
opposite 4 – Jonas Blaymires, plan of Waterford Cathedral as engraved in THE WHOLE WORKS OF SIR JAMES WARE, 1739 (courtesy National Library of Ireland)

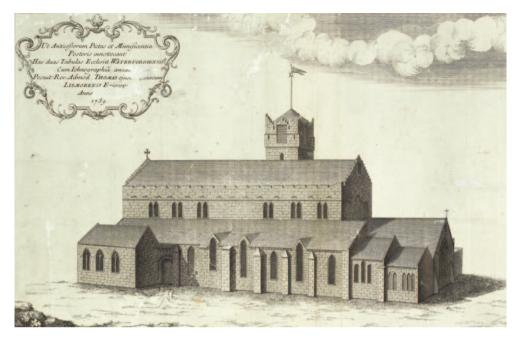
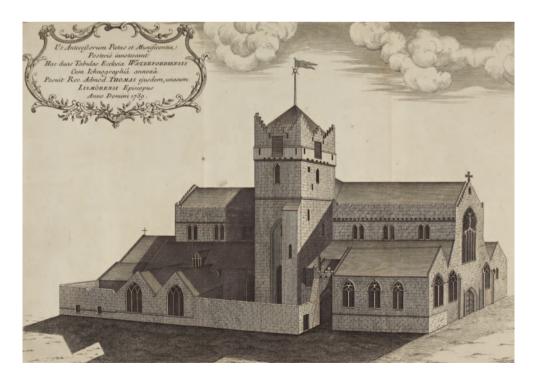
5, 6 – Jonas Blaymires, two views of Waterford Cathedral, from the south-east and from the north-west, as engraved in The Whole Works of Sir James Ware, 1739 (courtesy National Library of Ireland)

Unfortunately the exterior views of the cathedral do not throw any light on these issues. To the south, the aisle walls were pierced by a series of early Gothic lancets, those in bays 2, 4 and 5 being taller than the rest, their pointed heads rising into the roof where they were capped with gables (Plates 5, 11, 12).⁷⁸ In bay 6, there was a round-headed doorway, covered in the eighteenth century by a timber canopy. One of the drawings seems to indicate the presence of shaft rings, suggesting that it was a thirteenth-century addition. The same might be true of the west doorway, judging from the moulded jambs indicated in the Blaymires engraving.

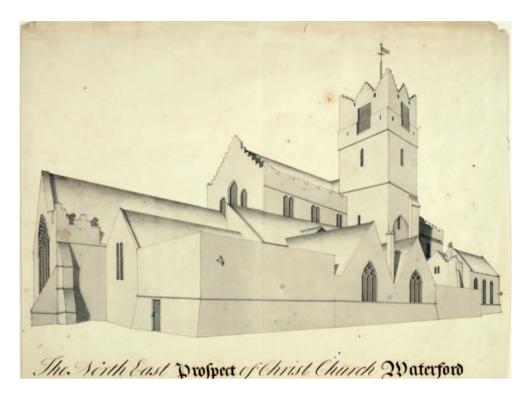
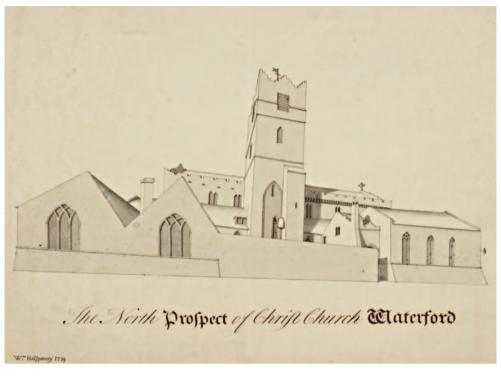
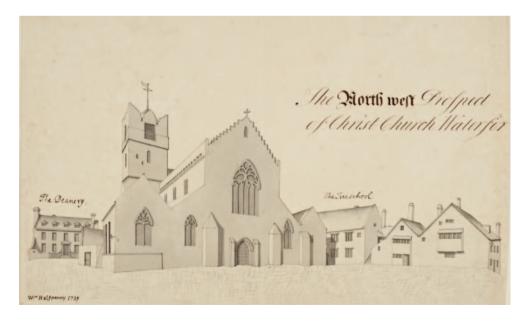
William Halfpenny, Waterford Cathedral, 1739
8, 9 – Drawings of the cathedral from the north (NLI, 1977, TX 2) and north-west (NLI, 1977, TX 3)
opposite 7 – Drawing from the north-east (NLI, 1977, TX 1)
(all courtesy National Library of Ireland)

Blaymires' approach was quite different from that of William Halfpenny, whose three views (from the north-east, north and west) were taken from a low viewpoint.⁴⁶ Drawn in ink with a brown wash, they are signed at the bottom-left corner 'Wm Halfpenny 1739'. The low viewpoint, emphatic foreshortening and sparse technique accentuate the geometric mass of the building, the overall effect stark and dramatic (Plates 7-9). Halfpenny's plan of the cathedral (Plate 3) is more accurate than that by Blaymires.⁴⁷ It is drawn in black and sepia ink, with grey and yellow washes. The scale is ⁷/8 of an inch to 10ft, from which one can calculate that the external length of the cathedral was 195ft (59.4m). Unlike Blaymires, Halfpenny did not mark the position of tombs nor did he identify specific chapels, but staircases, choir stalls, altars and other features are more precisely delineated. Whereas Blaymires tried to give an impression of the multi-shafted piers in the choir, Halfpenny was content to mark them as rectangular blocks.

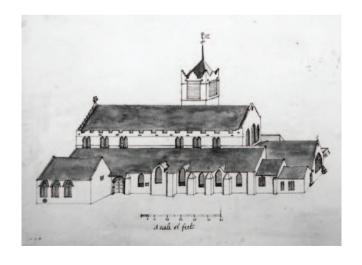
10 – Drawing of the cathedral from the north-west (NLI, 1977, TX 6)

11 – Drawing from the southwest (NLI, 1977, TX 5)

12 – Drawing from the south (NLI, 1977 TX 4)

(Plate 11).⁵⁰ Especially distinctive are the delicate, spindly outlines of the tracery in the windows. The third drawing is somewhat cruder, this time a high-level view showing the cathedral from the south (Plate 12).⁵¹ Drawn in brown ink, it is characterised by heavy, uneven washes applied to the roofs. It has two obvious similarities with the previous drawing: in both cases the individual windows are filled with lattice patterns, suggesting small rectangular panes of glass, and in both works a scale is provided, an indication perhaps that the drawings were intended as some sort of record rather than as artistic compositions in their own right.

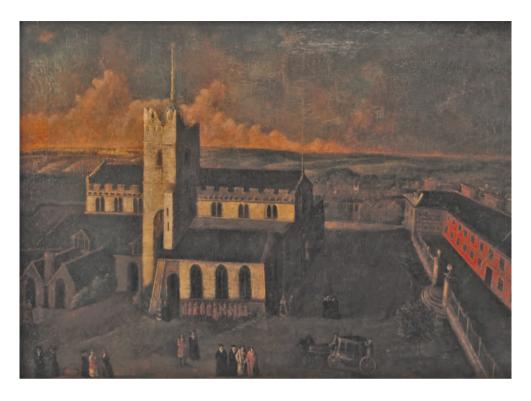
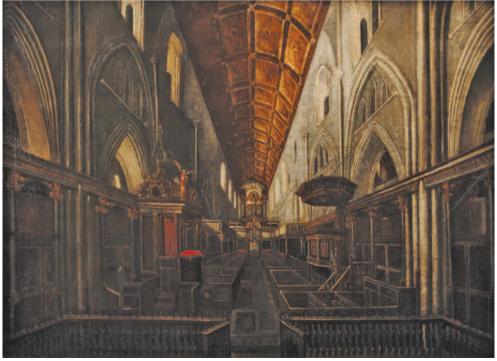
opposite 13, 14 – Two paintings of the cathedral by an unknown artist, c.1730 (?): the exterior from the north and the interior of the choir looking west (Waterford Museum of Treasures)

More ambitious depictions of the old cathedral come in the form of a pair of oil paintings, now hanging in the Waterford Museum of Treasures at the Bishop's Palace.⁵² One is an aerial view showing the building from the north-west, with the city and hills beyond (Plate 13); the impressive red brick façade of the 'Apartment' is prominently depicted on the right. There is much human activity in the foreground, including dignitaries along with a coach, complete with footman standing at the back.⁵³ Unfortunately, the dark surface makes the details hard to discern. But there is one noticeable feature not found in other views, namely the omission of the wall running continuously from the tower to the eastern chapels. In its place there is an open yard filled with bushes and undergrowth, an indication, perhaps, that the painting preceded the other views. If so, it must have been made before 1739.

By far the most important of all the visual records is the second painting in the Waterford Museum. This is an interior view of the cathedral as seen from the high altar, looking west (Plate 14). It provides abundant information about the medieval architecture, as well as the furnishing of the choir. Especially noticeable is the bishop's throne, an extravagant affair, with an elaborate canopy protected by a brightly painted angel.⁵⁴ But it is the architectural detail that makes the work so valuable; without the painting, the design of the Gothic choir would be completely unknown. A date of about 1730 has been suggested; the painting was certainly made before 1752, as there is no sign of the renovations described by Richard Pococke (these included black and white paving in the choir and 'handsome' canopies over the seats of the mayor and aldermen).⁵⁵ In addition to specific views, there are a number of general illustrations of the city that show the cathedral from a distance. These include an engraving of 1673 and a painting by William van der Hagen, the latter commissioned by the Corporation of Waterford who paid £20 for it in 1736.⁵⁶

The architecture of the interior is well illustrated in the painting (Plate 14). There was a three-storey elevation consisting of an arch leading to the adjacent aisle, a triforium with three graded arches, and a clerestory with a mural passage set in front of the windows.⁶⁸ The most striking aspect of the scheme is the manner in which a network of shafts rises from the pier, the centre shaft continuing up to the springers of the vault.⁶⁹ Two further shafts enclose the main arcade and the triforium, producing the 'giant' order. The height of this arch must have added considerable force to the overall design. The painting also shows a distinctive treatment of the arches leading into the adjoining aisles; here the mouldings were restricted to the angles, leaving the centre of the soffit quite plain, a technique defined over a century ago by Arthur Champneys as a 'reduced order'.⁷⁰

Only three bays of the choir were complete to their full height. In the fourth bay on the south side (left in the painting) there is no sign of a clerestory, while in the corresponding bay to the north there is little, if any, indication of Gothic work. The blank wall in this area is explained by the presence of the tower alongside. The tower itself is in a curious position, placed above the aisle, halfway along the north side of the church. The construction of a tower over a pre-existing aisle would have been a hazardous undertaking at the best of times. In its final form, the tower was clearly a late medieval construction, but we know it replaced an earlier 'belfry' that fell in a storm in 1366-67. It is thus possible that the location of the tower was established before the Gothic choir was begun.⁷³

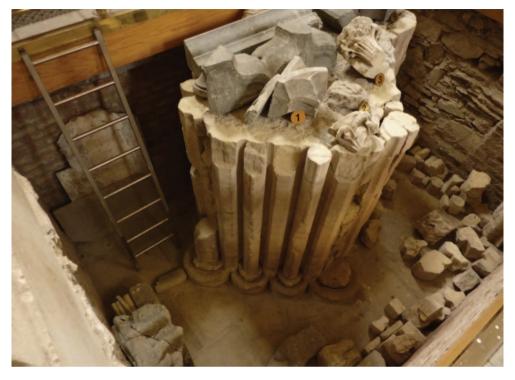
15 – The surviving pier in the south arcade (pier 3), photographed from the north
Carved fragments from the medieval cathedral are arranged on the upper surface (all photos by the author)
16 – Plan of the surviving pier in the south arcade (pier 3)
17 – Design of pier in the north arcade (pier 2)
(as reconstructed by the author of the basis of evidence found in 2011)

Numerous fragments of sculptured and moulded stone also remain, some displayed in the narthex beside the medieval pier (Plate 15). They include a voussoir decorated with chevron ornament, and three stiff-leaf capitals dating from the early thirteenth century (Plate 19). There is also the head of a two-light window with foliate decoration in the spandrels.⁶² More fragments were exposed when the walls of the current building were uncovered, prior to replastering and re-rendering.⁶³ It is important to note that the majority of the tombs recorded by Blaymires have survived, though it appears that, at the time of his visit in 1739, some medieval monuments had already been lost.⁶⁴

More information about the construction of the choir can be gleaned from the unusual pier (pier 3) that separated the third and fourth bay. Although beautifully built in imported Dundry stone, its plan is unorthodox, not to say perplexing (Plates 15, 16). The irregularities are clearly deliberate, for the handling of the stone is consistent throughout and the pier appears to have been erected in one build. The north-south axis has been shifted approximately 0.57 metres to the west (on the south side) while the east-west axis has been moved approximately 0.35 metres to the north (on the north side). Presumably the irregularities were intended to overcome a particular problem at this point in the cathedral. Halfpenny in his plan spotted the irregularities, though Blaymires ignored them.⁷⁴

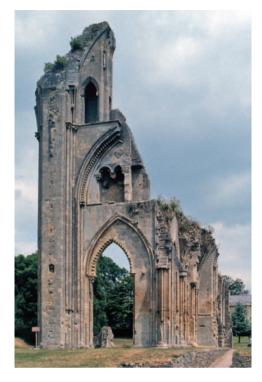
18 – Glastonbury Abbey: the ruins of the great church showing the east face of the transepts

enclosed by a great arch springing from ground level. Given the wealth and prestige of Glastonbury, it is surprising that the monks opted for a composition that was already becoming *retardataire*; the contrast with the contemporary architecture at Wells, not far away, has often been noted. Nothing is known about the Romanesque church at Glastonbury, but it is possible that the elevation incorporated a giant order, which the monks were anxious to retain.
